Rock slope kinematics analysis by Markland method of the Bener District, Purworejo Regency, Central Java, Indonesia

Sari Bahagiarti Kusumayudha, Azwar Thamrin, Heru Sigit Purwanto

Department of Geological Engineering, Faculty of Mineral Technology, Universitas Pembangunan Nasional "Veteran" Yogyakarta, Yogyakarta, Indonesia

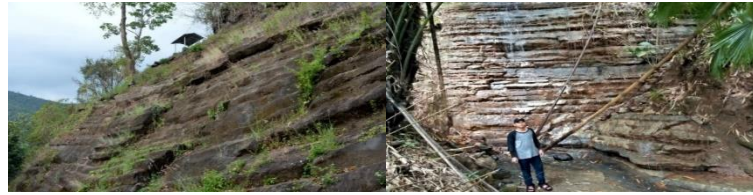
Figure 6. Andesite lava with columnar joint structure at Pajangan Hill, Sentolo Formation

Conformably overlaying the Kaligesing Formation, there is the Sentolo Formation. It consists of bedded limestone, calcareous sandstone, calcarenite, and sandy marl (Figure 6). In the calcareous sandstone, there are often found lithic fragments, allochem foraminifers, skeletal, calcite matrices, with carbonate mud cement. In general, the slope of this rock unit is trending southwest, with a position of N 155°E/5°. Alluvial deposits are produced by river stream and flood sedimentation, consisting of clay, silt, and sand-sized materials, andesite fragments, volcanic materials, and limestone-sandstone fragments of granule to boulder-sized.

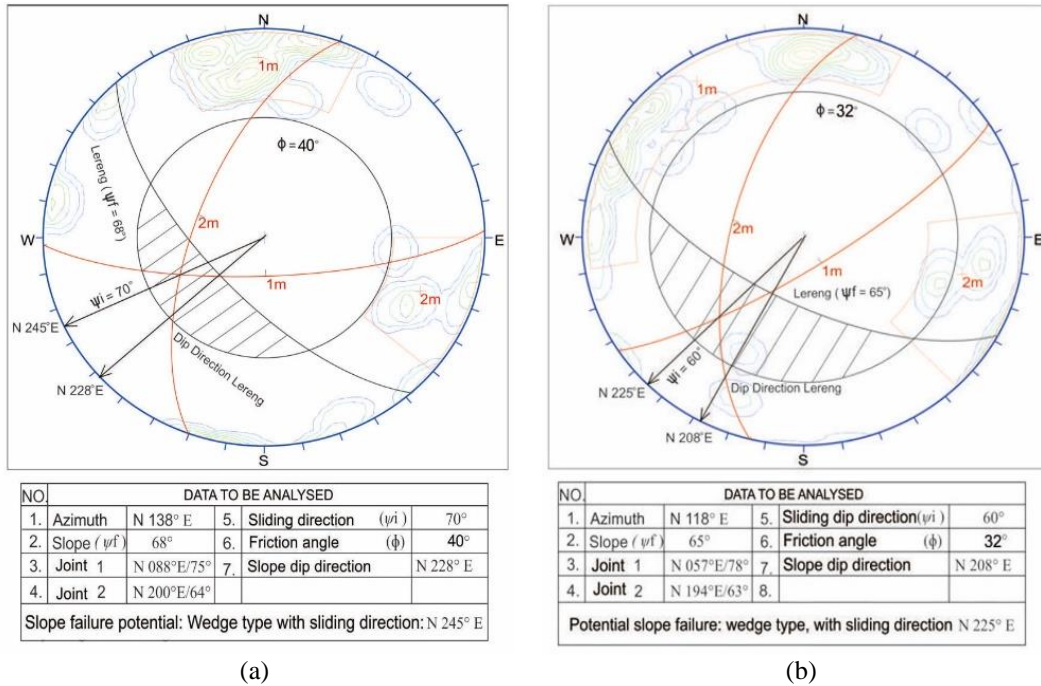
Figure 8. Kinematic analysis with potential wedge failure of (a) Kaliwader slope A and (b) Kaliwader slope B

Afterward, RMR was carried out on slope constituent rocks. From the computation of RMR, Kaliwader slopes, Argosari slope, and Wadas slope have an RMR value ranging from 45 to 48, classified as fair rock. It means that discontinuities quite exist on the rock mass. Results of the stereonet plots, kinematics analyses, as well as RMR scorings are displayed in Figures 8-10, Figure 8(a) shows kinematic analysis with potential wedge failure of Kaliwader slope A, and Figure 8(b) shows kinematic analysis with potential wedge failure of Kaliwader slope B. Figure 9(a) shows kinematic analyses of Kaliwader slopes C with wedge failure potential and Figure 9(b) shows kinematic analyses of Kaliwader slope D with no failure potential. Figure 10(a) shows a kinematic analysis of the Argosari slope with wedge failure potential and Figure 10(b) shows a kinematic analysis of the Wadas slope with planar slide failure potential. The consequences of the analyses reinforce that geologic structures, lithological properties, and geomorphography play the main actors in rock slope failures.

No.	Location	Lithology	Rock mass rating	Type of rock slope failure potential
1	Kaliwader A	Volcanic breccia	$c = 21.8 \text{ Kpa}$, $\phi = 40^\circ$, $\gamma = 1.805 \text{ g/cm}^3$, $\sigma = 12.41 \text{ Mpa}$; RMR = 45	Wedge failure, sliding direction: N 138° E
2	Kaliwader B	Weathered andesite lava	$c = 15 \text{ Kpa}$, $\phi = 32^\circ$, $\gamma = 2.077 \text{ g/cm}^3$, $\sigma = 6.62 \text{ Mpa}$; RMR = 48	Wedge failure, sliding direction: N 128° E
3	Kaliwader C	Andesite lava	$c = 39 \text{ Kpa}$, $\phi = 51^\circ$, $\gamma = 2.077 \text{ g/cm}^3$, $\sigma = 6.62 \text{ Mpa}$, RMR = 48	Unpotential to fail
4	Kaliwader D	Andesite lava	$c = 39 \text{ Kpa}$, $\phi = 51^\circ$, $\gamma = 2.077 \text{ g/cm}^3$, $\sigma = 6.62 \text{ Mpa}$, RMR = 47	Planar slide, sliding direction: N 340° E Wedge failure, sliding direction: N 002° E
5	Argosari	Weathered andesite lava	$c = 39 \text{ Kpa}$, $\phi = 35^\circ$, $\gamma = 2.077 \text{ g/cm}^3$, $\sigma = 6.62 \text{ Mpa}$; RMR = 48	Wedge, sliding direction: N 225° E

According to Markland method analysis, Kaliwader slopes A, B, and Argosari slope have the potential for wedge failure, Kaliwader slope D and Wadas slope have the potential for planar slides and wedge failure types, and Kaliwader slope C is stable. The findings of this analysis can be used by the local government as one supporting data in developing a map of mass movement vulnerability zones. It will also serve as a resource for territorial development and disaster risk reduction and mitigation in communities.
